UNION VILLAGE DAM

OMPOMPANOOSUC RIVER, UNION VILLAGE VT.

SITUATION REPORT

APRIL 1976

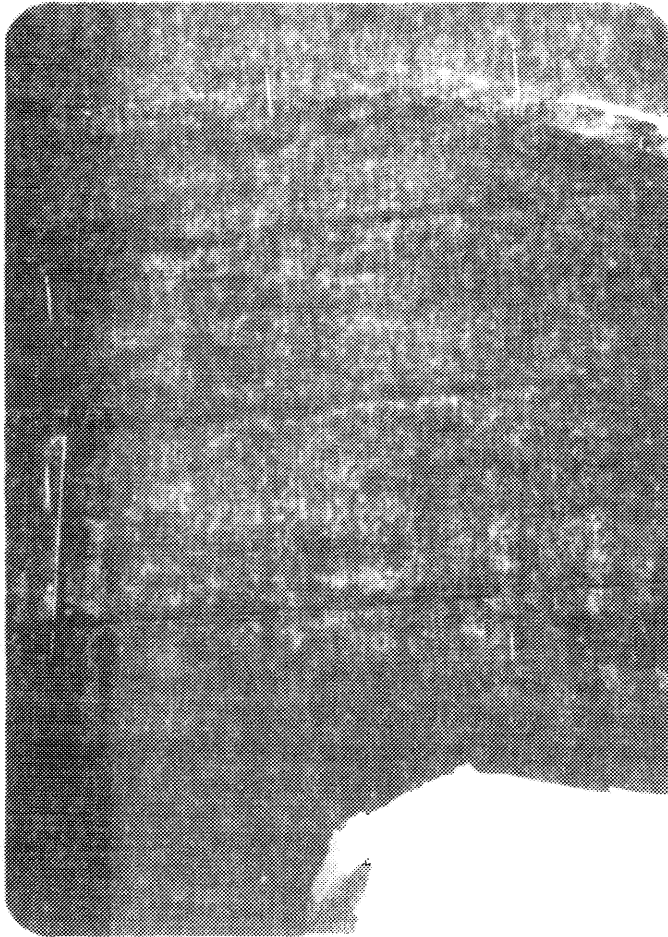
Spillway left training wall, close-up view showing good condition.

The concrete retaining walls appear to be in very good condition. Groundwater flow was noted discharging slowly from the downstream retaining wall drains.

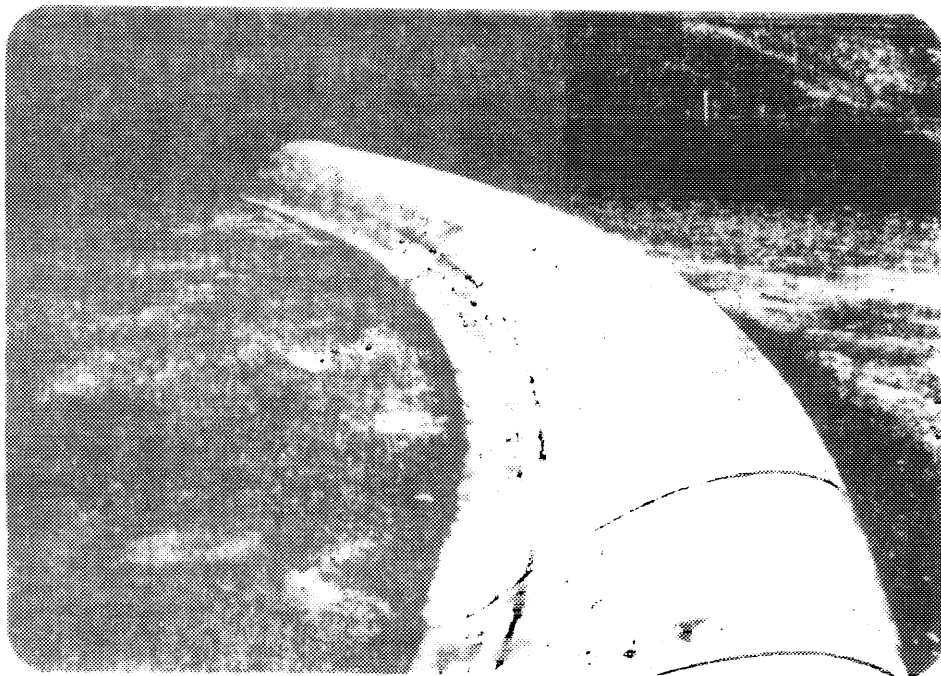
Spillway ogee weir and right rock cut wall, looking west.

3. Spillway Weir and Retaining Walls - Surface spalling occurs on the downstream face of the spillway at the intersection of the vertical and horizontal construction joints. Depth of spalling at the most damaged area is approximately 2 inches deep and tapers back to zero, approximately 18 to 24 inches away along the horizontal joint. This horizontal joint, 8 feet below the crest, is also surface spalling along its length at various locations and appears as if a previously placed mortar patch is lifting off. In general, the spillway weir concrete surface appears in good condition except for minor surface spalling as noted.

Structural modifications consisting of rock anchors are required on the spillway weir, and spillway wall in order to comply with updated design criteria, however, the deficiency is not critical at this time.

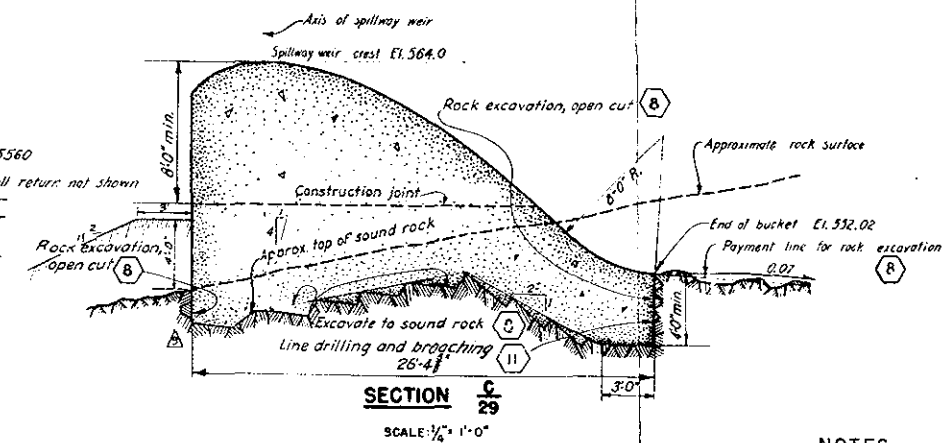
SECTION C 29

The remaining stability requirements are satisfied for all of the loading cases analyzed for Section C/29 and foundation pressures for all of the cases are within the allowable bearing pressure for the rock.

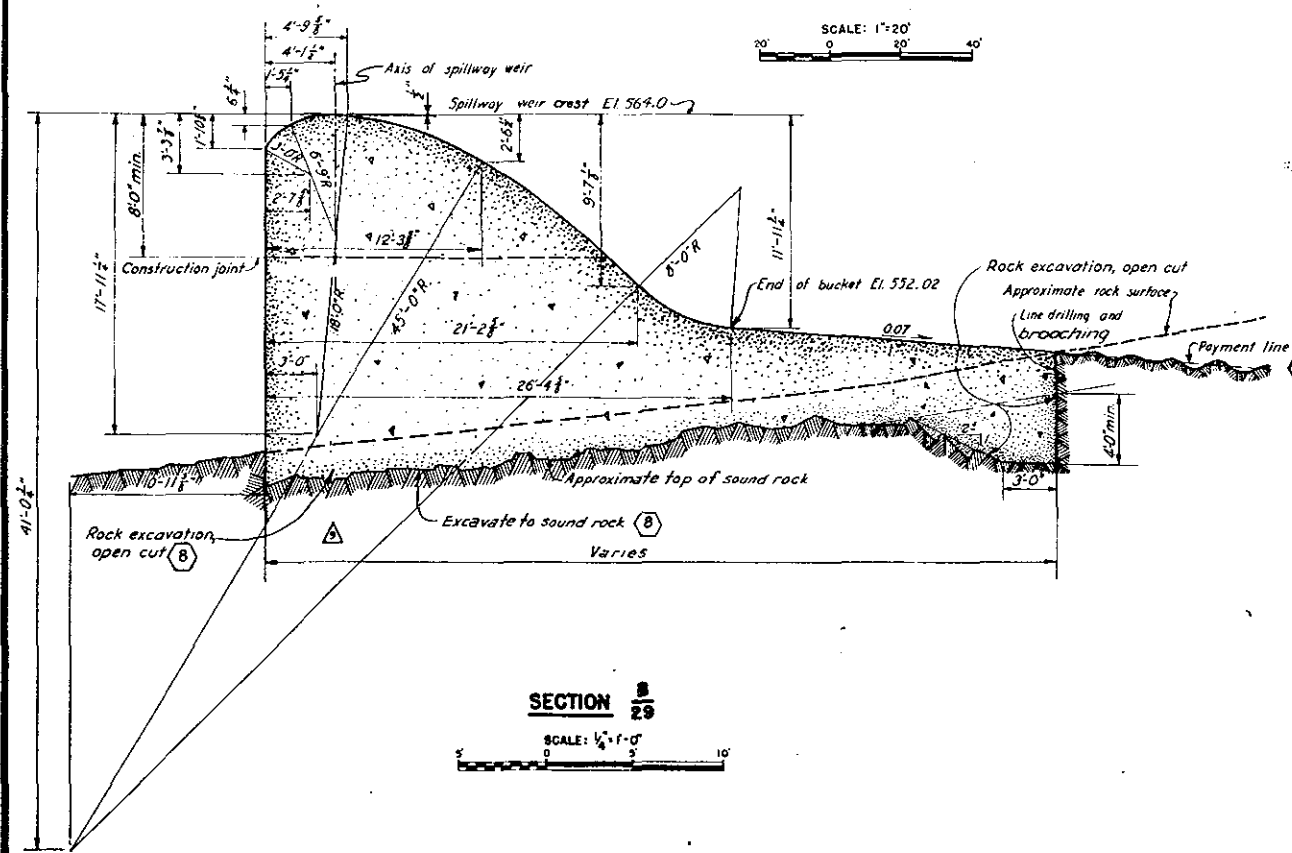
SECTION B 29

The resultant is within the middle third of the base in all cases analyzed for Section B/29, as shown on Sheet 28 of the original contract drawings, and is representative of two of the fourteen weir monoliths. The overturning stability criteria is not satisfied for Section C/29 under Loading Cases II and IV. To satisfy the overturning stability criteria, remedial measures are recommended for approximately 330 feet of the spillway weir where no anchorage system was provided.
